Manhole Inspection Summary

Manhole # S45E2_017MH

Insp Date: **12/20/07 1:17 PM**

Location Address: **4000 Fairhaven Ave**

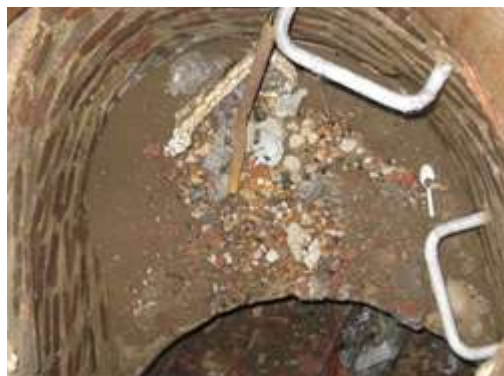
Defect 2

Debris

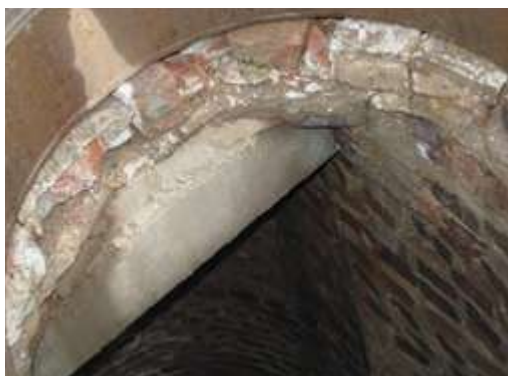
Defect 1

Condition: ☐ Sound ☐ Cracked ☐ Root Intrusion ☒ **Loose Brick** ☐ Deteriorated

Infiltration: ☐ None ☒ **Joint** ☐ Cracks ☒ **Mortar** ☐ Roots ☐ Wall

Loose bricks/infiltration

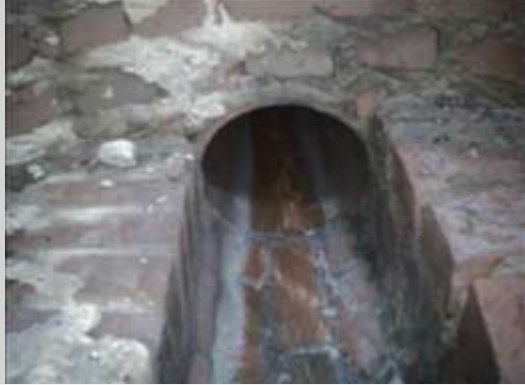
12 O'Clock Outflow

8 in. Circular Gravity Sewer
Pipe Out @ 12 O'Clock

Pipe Height: **10.8** (in.) Rod and Bar (Angled)
Pipe Material: **Clay** ☐ Pipe Lined
Invert Depth: **9.69** (ft.) Flow Characteristics: **Fast**
Deposits: ☒ None ☐ Mud ☐ Sludge ☐ Debris ☐ Grease
Silt Depth: (in.) Deposits Extent:
Infiltration: **None** Pipe Seal Cond: **Sound**

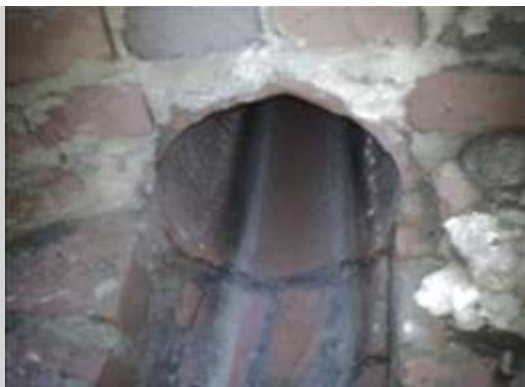
3 O'Clock Inflow

8 in. Circular Gravity Sewer
Pipe In @ 3 O'Clock

Pipe Height: **9.6** (in.) Rod and Bar (Angled)
Pipe Material: **Clay** ☐ Pipe Lined
Invert Depth: **8.66** (ft.) Flow Characteristics: **Fast**
Deposits: ☒ None ☐ Mud ☐ Sludge ☐ Debris ☐ Grease
Silt Depth: (in.) Deposits Extent:
Infiltration: **None** Pipe Seal Cond: **Cracked**

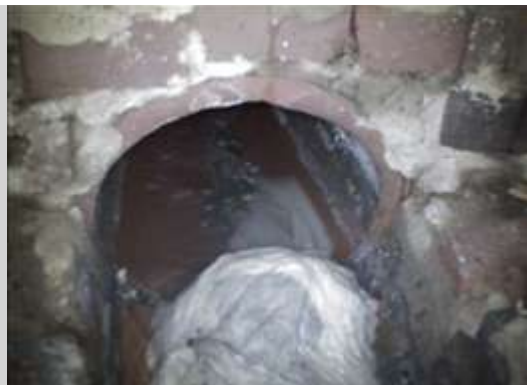
6 O'Clock Inflow

8 in. Circular Gravity Sewer
Pipe In @ 6 O'Clock

Pipe Height: **9.6** (in.) Rod and Bar (Angled)

Pipe Material: **Clay** ☐ Pipe Lined

Invert Depth: **8.69** (ft.) Flow Characteristics: **Fast**

Deposits: ☒ None ☐ Mud ☐ Sludge ☐ Debris ☐ Grease

Infiltration: **None** Pipe Seal Cond: **Sound**
